NHDOT Research Project 26962P
Reducing Cracks in New Bridge Curbs

Task 1: Review of Current Practices and Evaluation of Existing Concrete Curbs

April 2, 2017

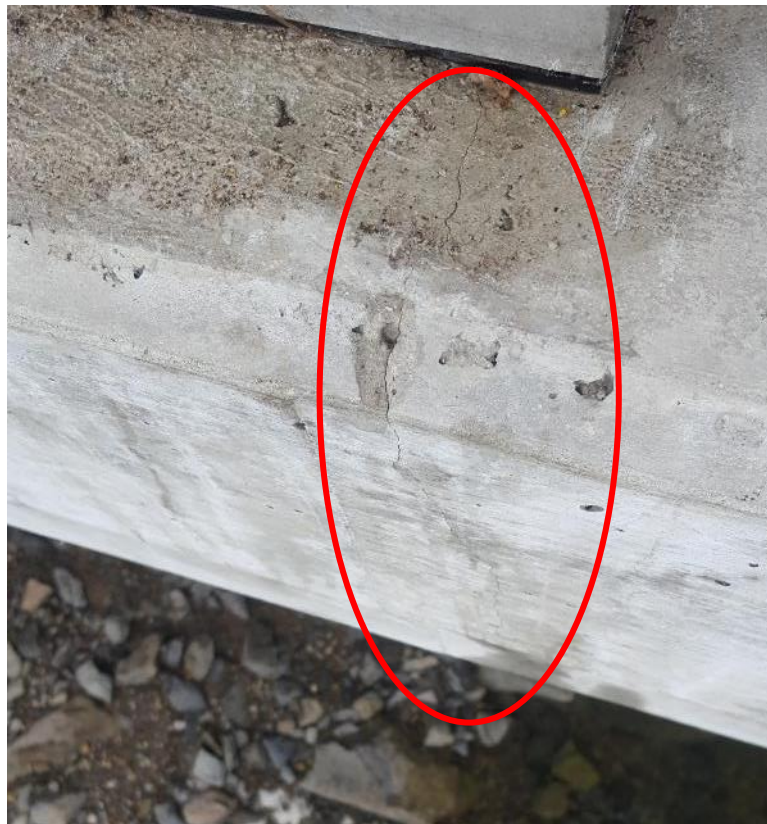
Figure 1: Sample of cracking on bridge curb in Hampton, NH.

An example of this early-age cracking are bridge curbs in Hampton, NH (Figure 1) along NH Route 101 that were recently replaced. The newly placed curbs were placed in the winter and kept in a heated “greenhouse” enclosures to keep hydration

continuing. Figure 1 was taken less than a month after the concrete for the south curb was placed and already exhibited multiple transverse cracks extending fully along each face. The 28-day compressive strength of the concrete used on this curb was approximately 6000 psi.

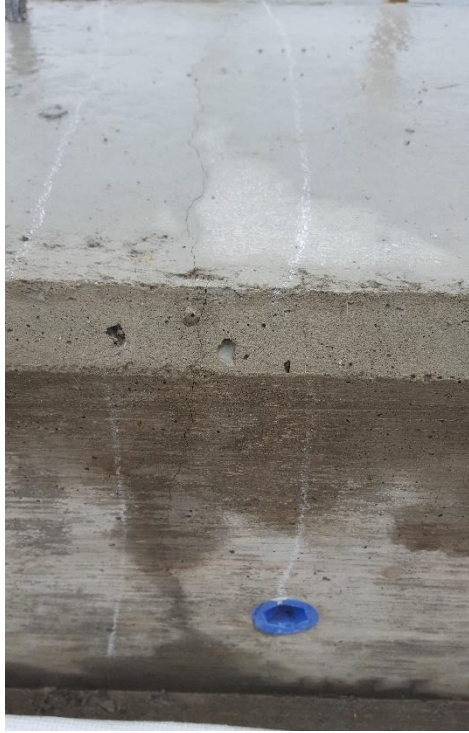
In March of 2017, the north facing curb was replaced. After five days of wet curing the formwork was removed (although curing was still continued) and four visible cracks had already formed (Figure 2). Three of the cracks extended the full length through the curb whereas one was confined to the top face. All four cracks occurred within the first third of one side of the bridge.

Figure 2: Cracking in the north curb 5-days after placement.

Two of the cracks formed within one foot of the anchor rods used to secure guardrail posts and the remaining two cracks were located “mid-panel”. The term “panel” is used here to describe the section of curb between two guardrail post locations. The curb is continuous with no joints but referring to sections between posts as panels simplifies the identification of crack locations.

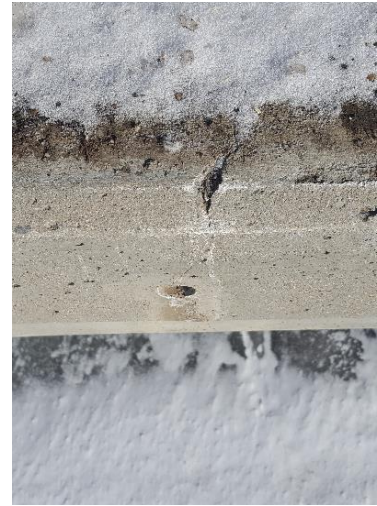
Figure 3: Crack extending through patch hole left from construction.

from formwork ties during the construction process (Figure 3).

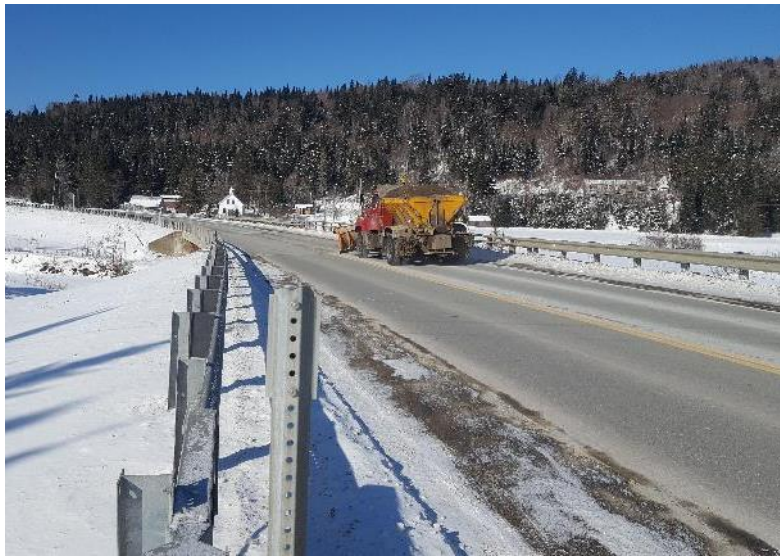
through Pittsburg and is therefore subject to a fairly large amount of heavier vehicles including school buses, plow trucks (Figure 4), and the more frequent logging trucks traveling at speeds around 55 mph. Another common observation is that many of the cracks along the bridge curb traveled through circular “patches” filling the voids

Figure 4: Plow truck crossing the bridge over Indian Stream in Pittsburg, NH.

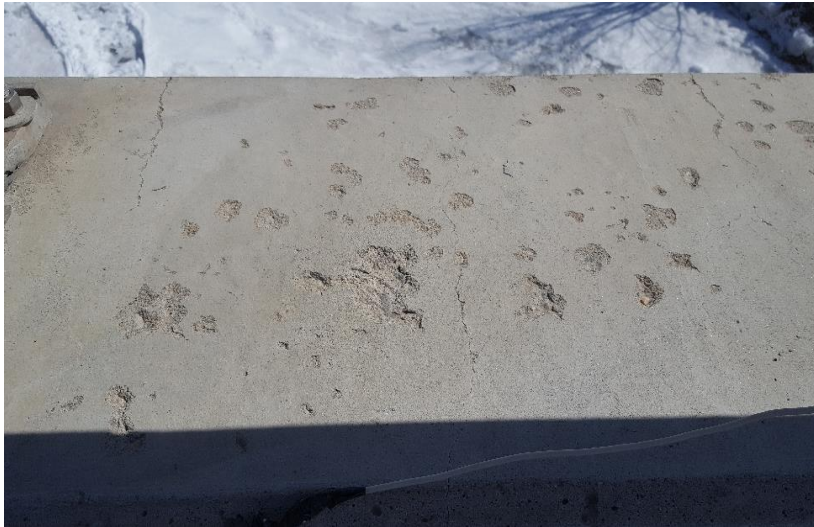
mid-panel cracks were often lower intensity (smaller crack width), confined to the top of the curb, and some panels had multiple cracks. Although cracking on the Israel River curb seemed less severe, the curb showed signs of scaling and pop-outs in addition to cracks (Figure 5).

Figure 5: Bridge over the Israel River in Jefferson. Signs of fatigue clearly visible on surface.
